TOWN OF LELAND

**PAVEMENT CONDITION AND PAVEMENT
MARKINGS CONDITION ASSESSMENT**

**BRUNSWICK ENGINEERING COMPANY
LICENSE NO. F-1380**

JANUARY 17, 2023

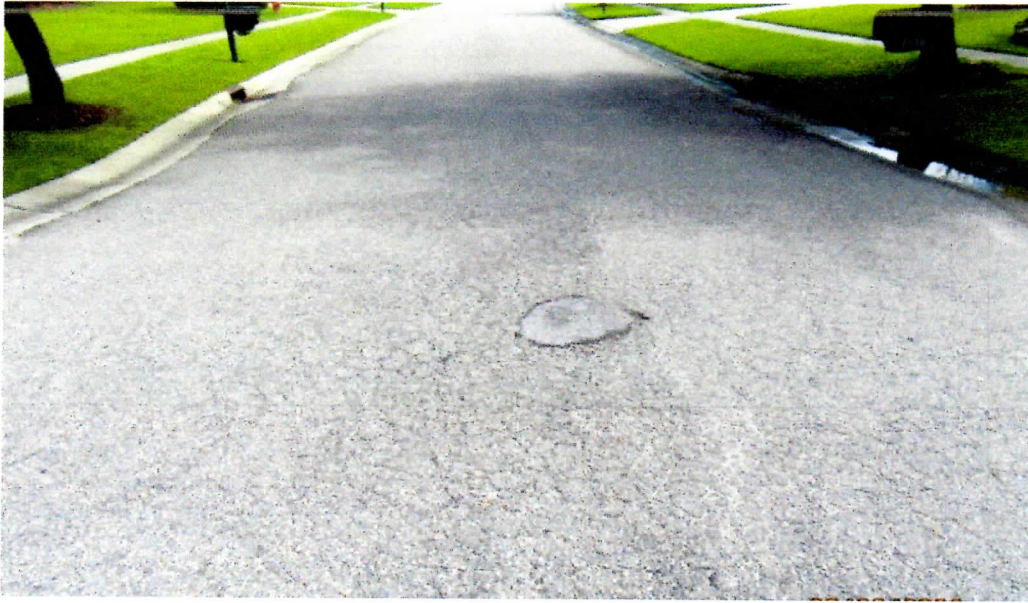
1. ALLIGATOR CRACKING

Alligator cracking is a series of interconnecting cracks caused by the failure of the base or subbase under traffic loading. The failure of the base or subbase results in cracks that connect, forming many sided, sharp angled pieces that develop a pattern similar to the skin of an alligator i.e., alligator cracking. Alligator cracking if left unrepaired could result in roadway failure and a potential increase in accidents due to pothole formation and loss of pavement.

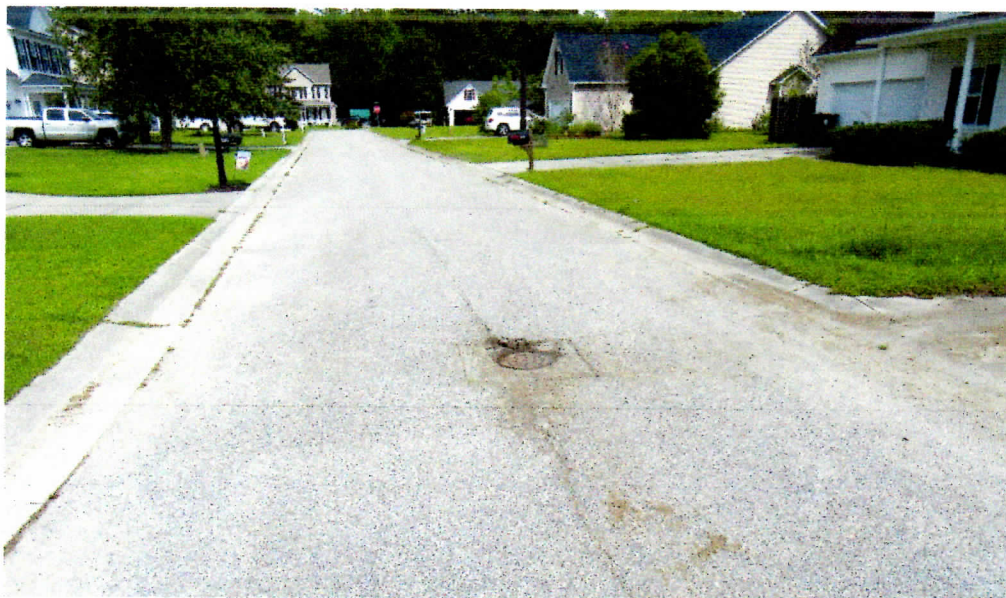
2. TRANSVERSE CRACKING

Transverse cracks extend across the pavement at right angles to the pavement centerline. These cracks are generally caused by differential base settlement or poor pavement construction techniques.

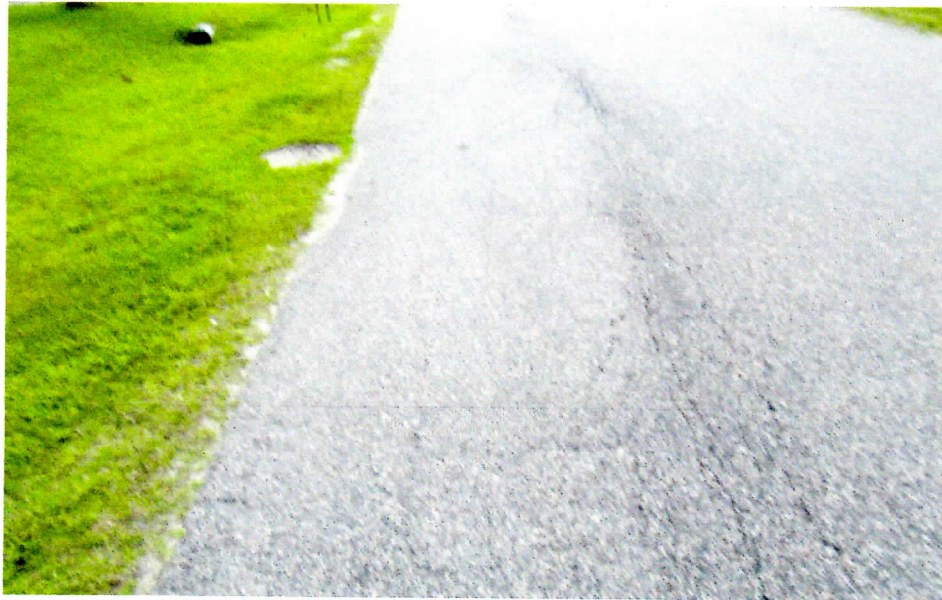
RAVELING

Raveling is the wearing away of the pavement surface caused by the dislodging of aggregate particles or loss of asphalt binder. Raveling can be caused by moisture getting between the riding surface course and the base course of asphalt.

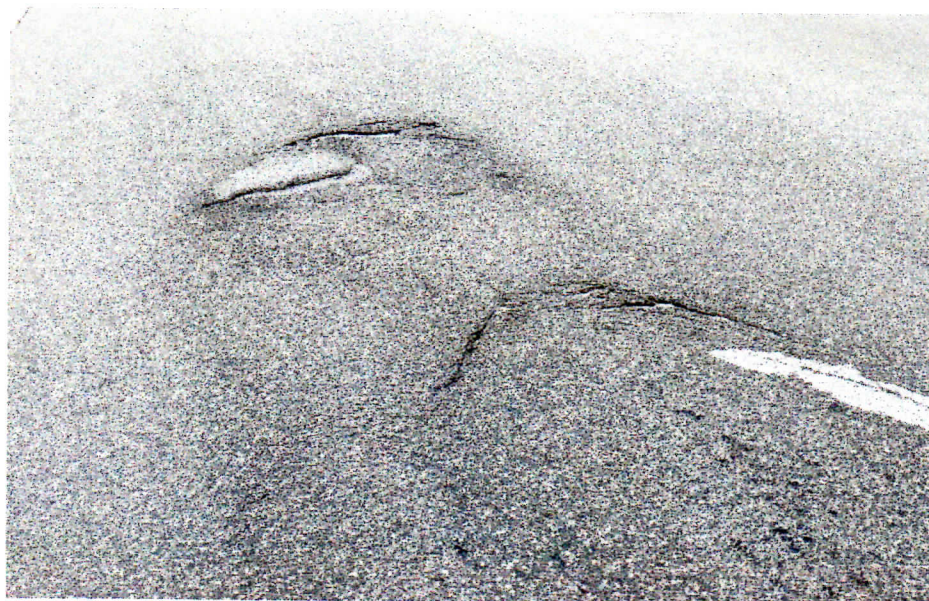
PAVEMENT SLIPPAGE

Pavement slippage is caused by the failure of the tack coat or prime coat to adhere to the riding surface. The resultant failure is generally crescent shaped and can occur at any time after the road has been paved or repaved.

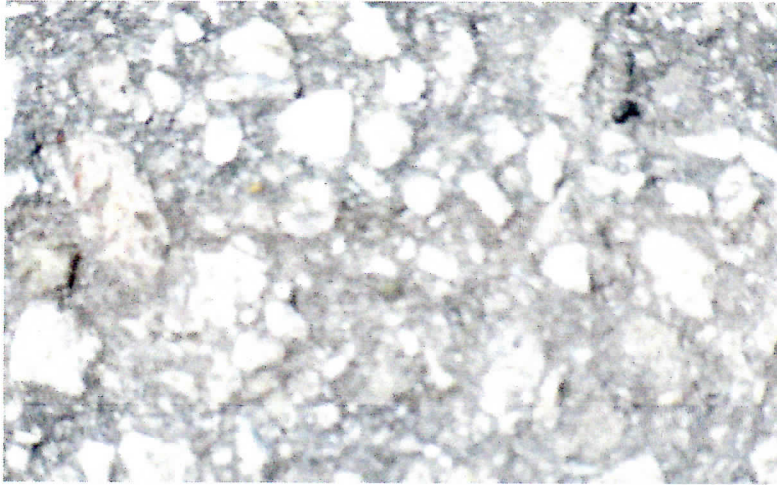
Pavement oxidation is the hardening and aging of the asphalt riding surface. The surface layer of asphalt has worn away or oxidized due to the sun's ultra violet radiation to expose the coarse aggregate. Pavement Oxidation usually covers the entire roadway surface.

SEVERE PAVEMENT OXIDATION

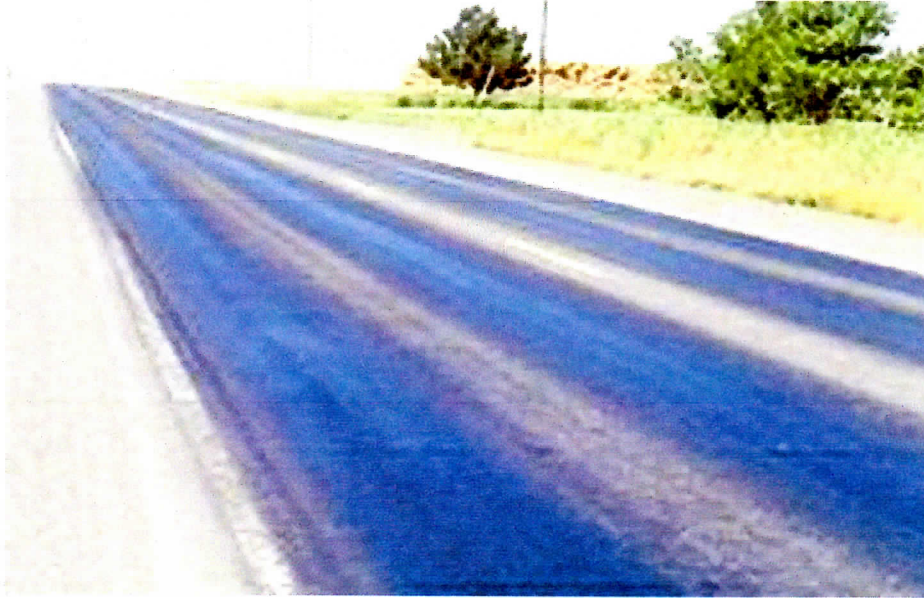
5. ASPHALT BLEEDING

Asphalt bleeding is a film of bituminous material on the pavement surface that creates shiny tar-like surface. Bleeding occurs during the hot summer months and is caused by excessive asphalt in the pavement mix, excessive tack coat, and/or low air void content.

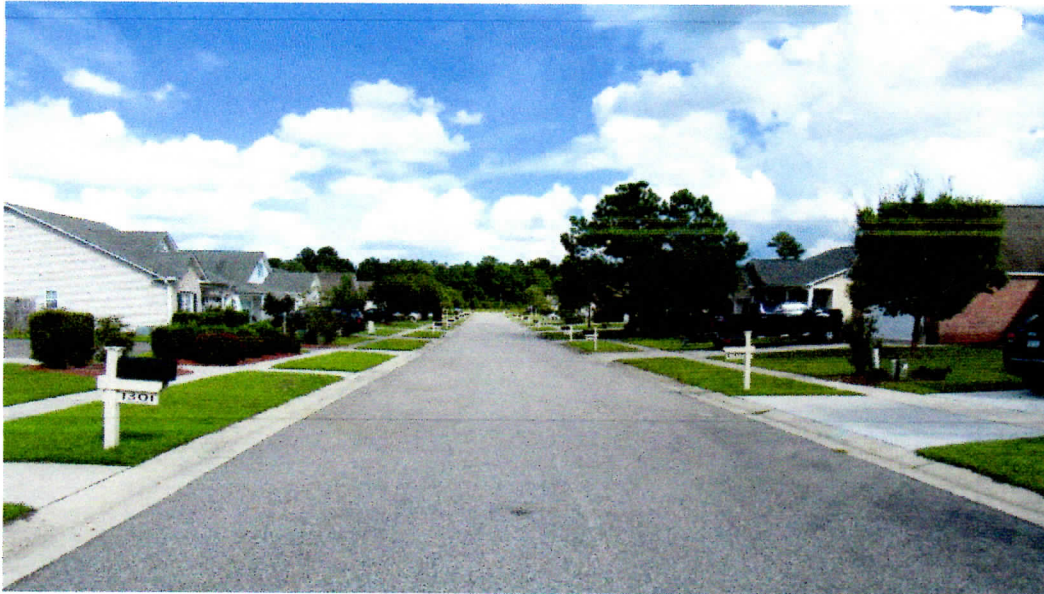
6. RIDE QUALITY

Ride quality is related to the surface condition of the road. It is a measure of how smooth or rough the surface is and is impacted by raveling, depressions, pavement patching, alligator cracking, and other pavement defects.

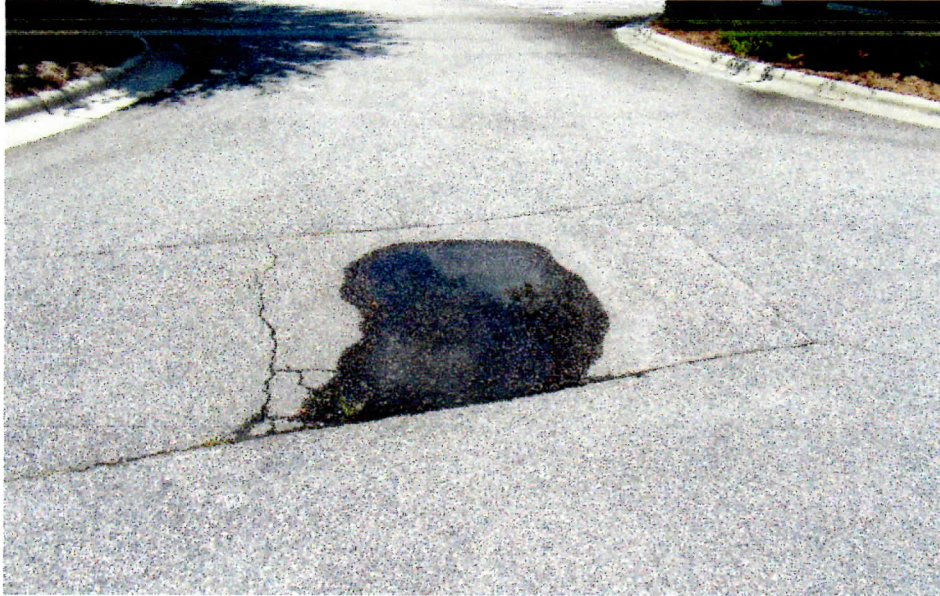
7. EXISTING UTILITY REPAIR PATCHES

An existing utility repair patch is an area of pavement that has been replaced with new material to repair the existing pavement. A patch is considered a defect no matter how well it has been repaired as it is more likely to fail than the surrounding original pavement.

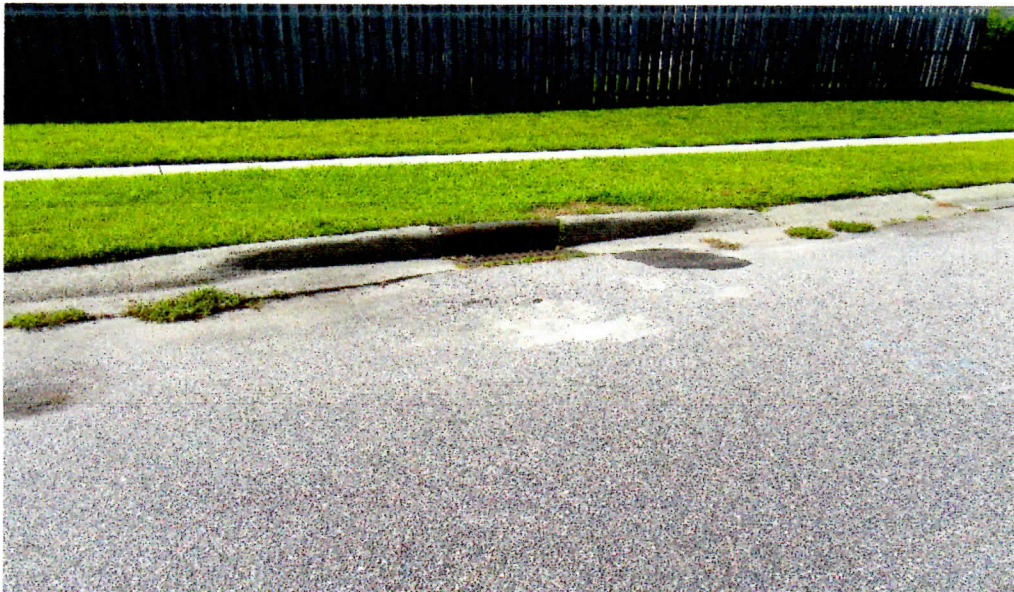
8. PAVEMENT DEPRESSIONS

Depressions are localized pavement sections where the pavement is lower than the surrounding pavement. Light depressions are called bird baths since they form after rainfall events. Deeper depressions can be a driving hazard. Depressions are caused by settlement of the base and subbase or improper construction. Depressions are often located at storm drainage or utility service pipe crossings where the dirt settles around the pipe.

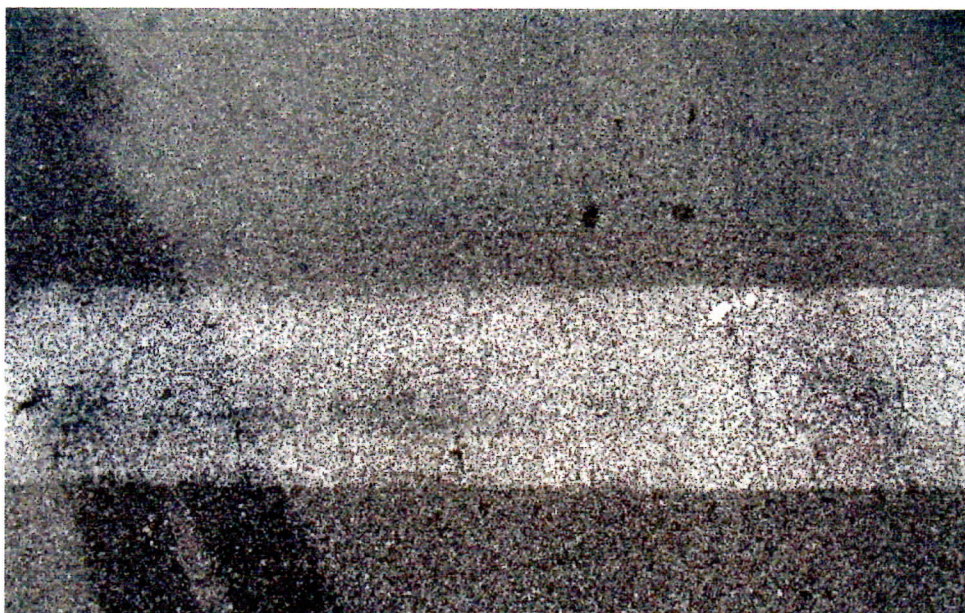
3. FAIR CONDITION

A pavement marking in fair condition is one that is visible to the motoring public that has significant wear or distortion. The motoring public can still see the pavement marking but it has lost its reflectivity and its purpose may not be evident.

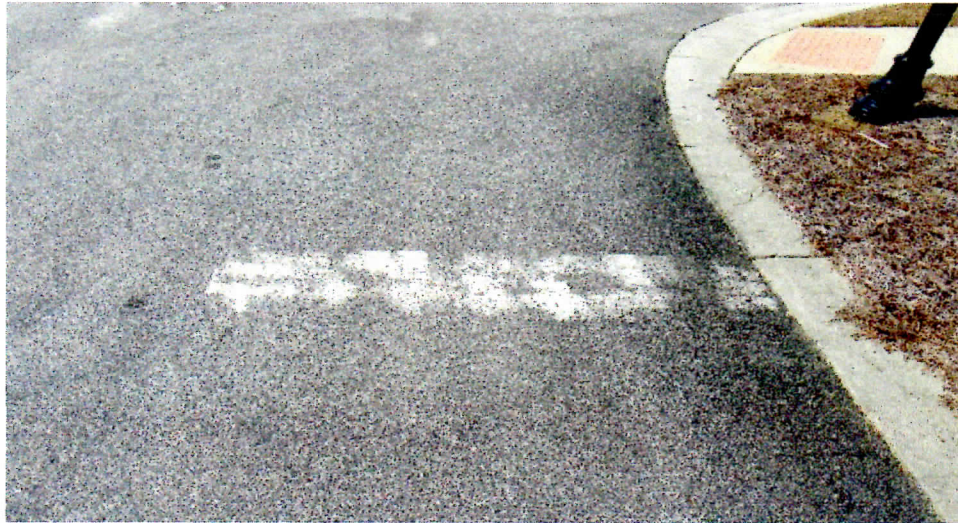
4. POOR CONDITION

A pavement marking in poor condition is one that is no longer visible to the motoring public that has significant wear or distortion. The motoring public cannot see the pavement marking, it has lost its reflectivity and its purpose cannot be determined by looking at it.
