**Watershed Watch
Base Monitoring Survey Report**

Date and Time: 6-15-22 12:17am

Location: Mill Creek Park

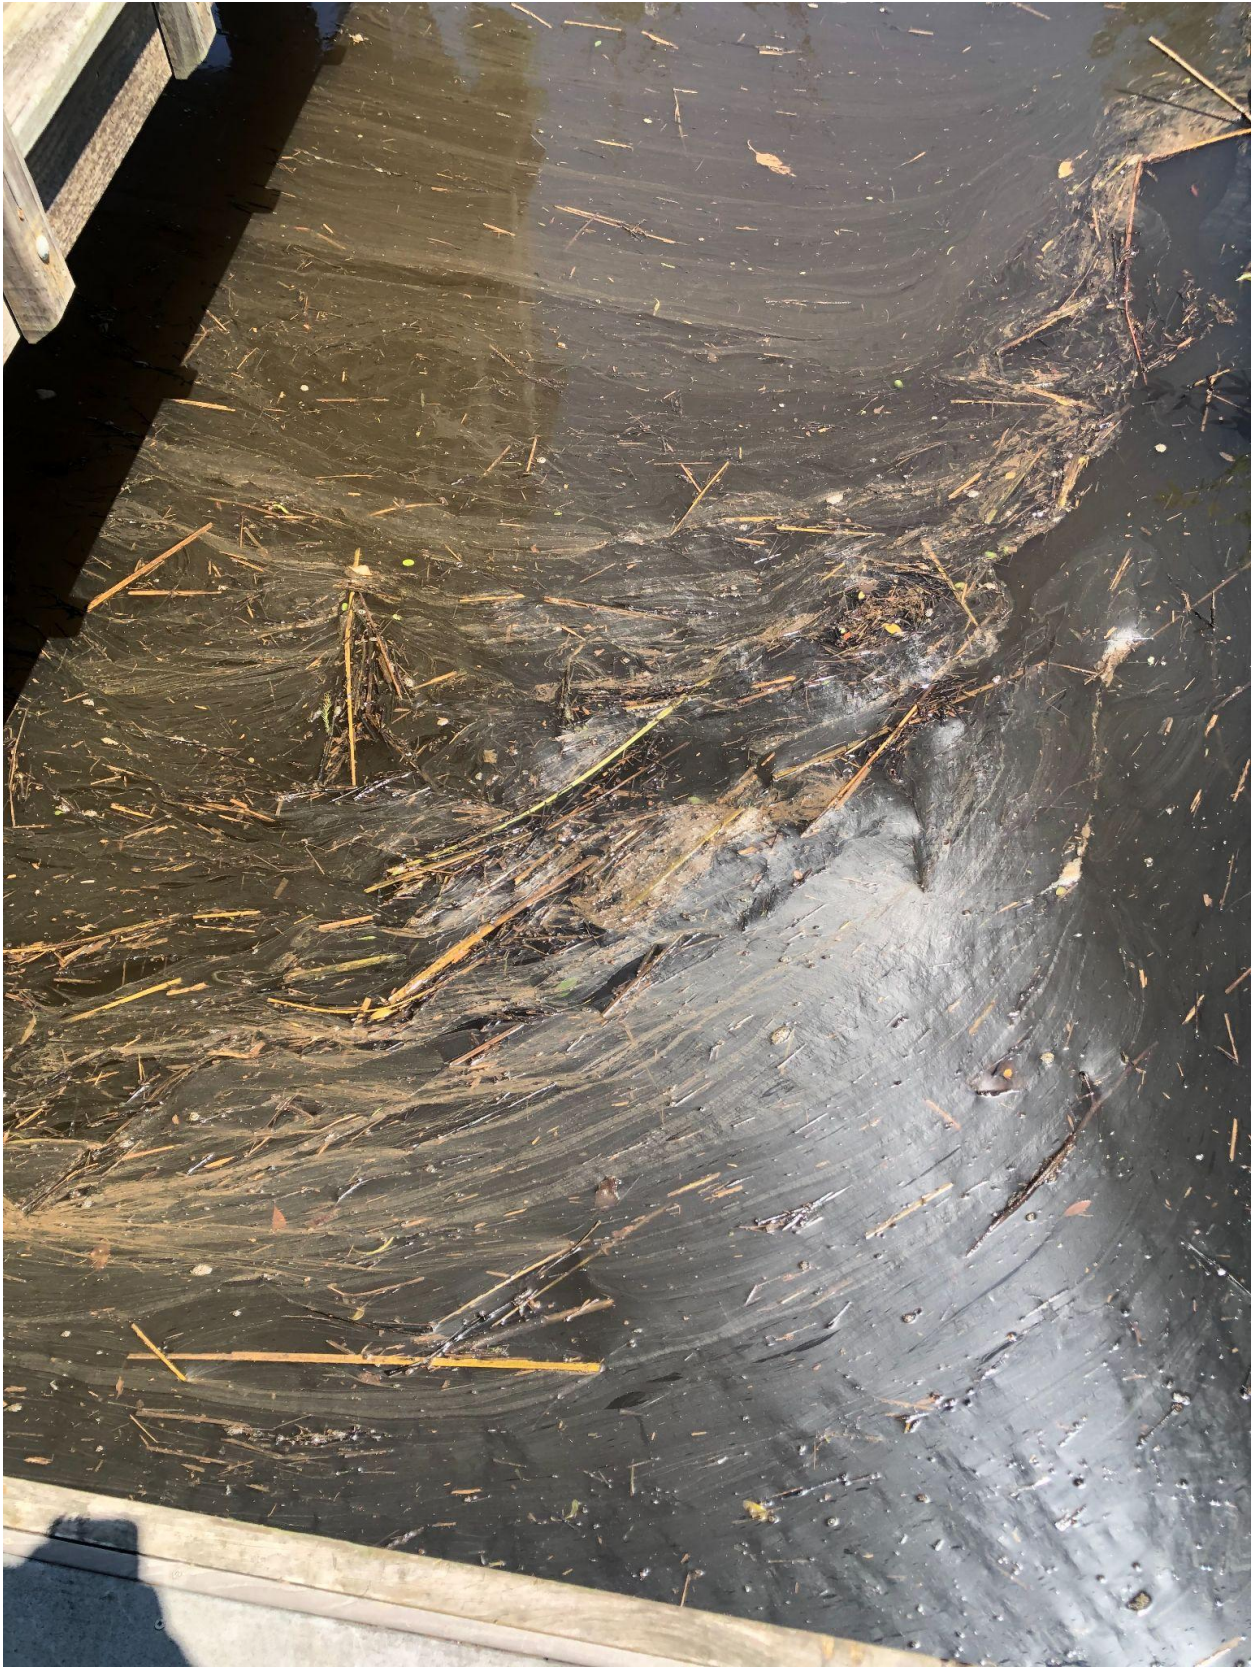
Water Surface:

- A. Water: Water surface was a brownish color with low flow. The turbidity was high. No odor present. Scum layer present on top of water. Elevated water level due to king tide.
- B. Creek Bottom: The creek bottom was not visible.
- C. Vegetation: Cypress trees, Bay trees, Maple trees, and Spartina grass.
- D. Pipes Present: No pipes present.
