### Watershed Watch Base Monitoring Survey Report

Date and Time: 6-15-22 11:20am Location: Mallory Creek Observers: Rob Clark Weather: Sunny, 88 degrees fahrenheit

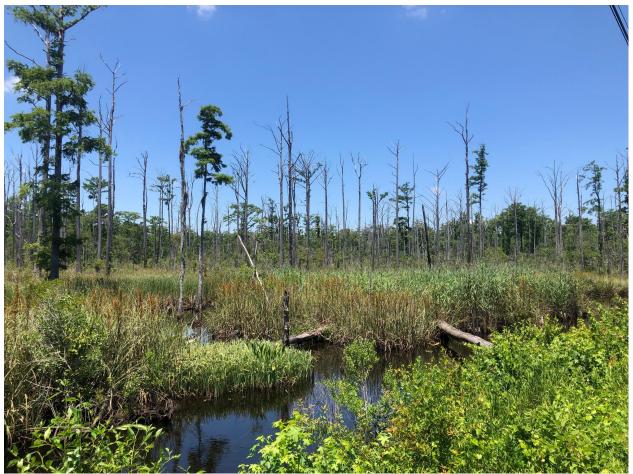
# Corridor(Wetlands):

- A. Creek Bank: Stable bank with vegetative cover.
- B. Runoff: Runoff from bridge and road.
- C. Corridor: Land use is private with wetlands present nearby. Major road runs over the creek.
