TOWN OF LELAND

**PAVEMENT CONDITION AND PAVEMENT
MARKINGS CONDITION ASSESSMENT**

**BRUNSWICK ENGINEERING COMPANY
LICENSE NO. F-1380**

JANUARY 17, 2023

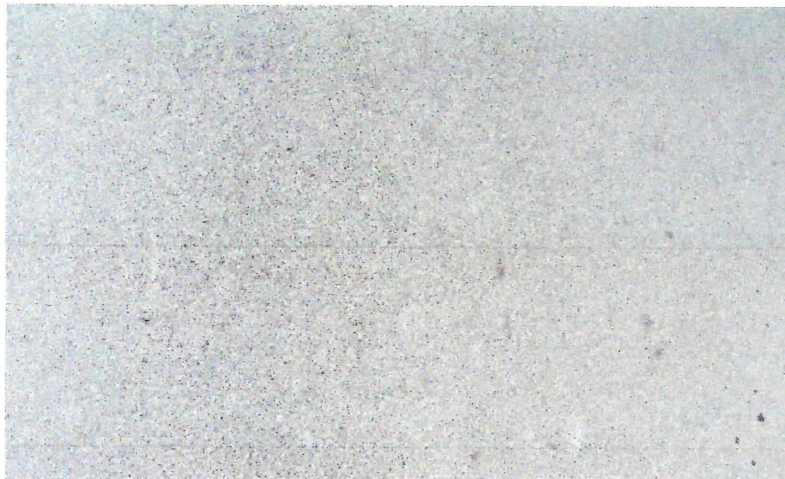
NO PAVEMENT OXIDATION

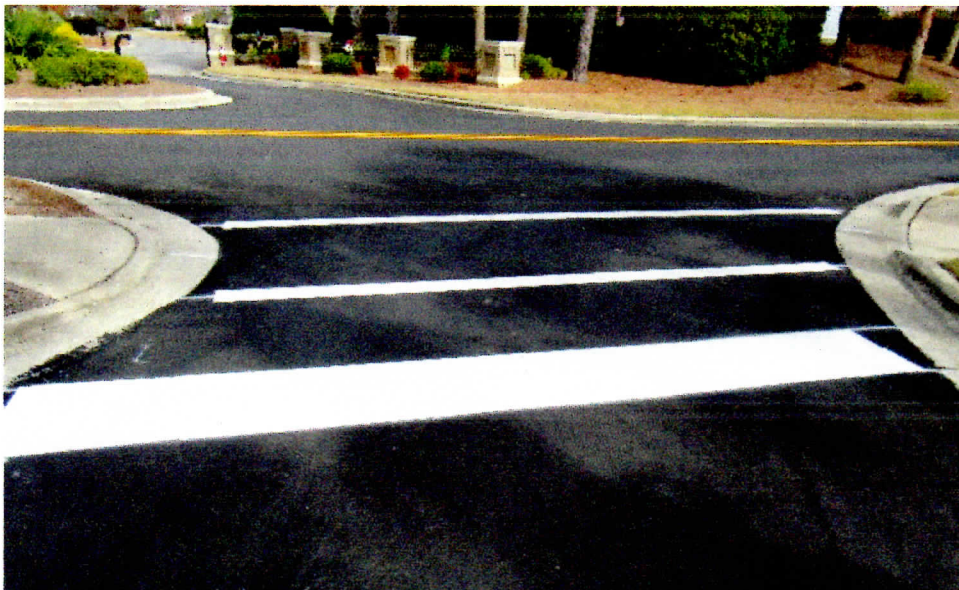
1. EXCELLENT CONDITION

A pavement marking in excellent condition is one that is clearly visible to the motoring public with no wear or distortion. All pavement markings in excellent condition are constructed with a permanent material such as thermoplastic materials.

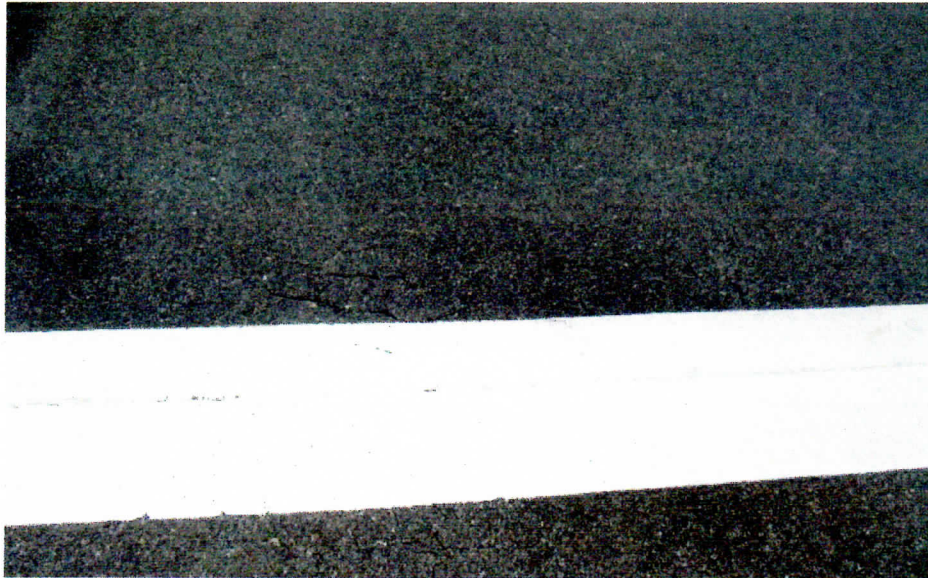
2. GOOD CONDITION

A pavement marking in good condition is one that is clearly visible to the motoring public that has some wear or distortion. All pavement markings in good condition are constructed with a permanent material or have recently been installed with a traffic paint.
