**Watershed Watch
Base Monitoring Survey Report**

Date and Time: 6-15-22 11:00am

Location: Sturgeon Creek

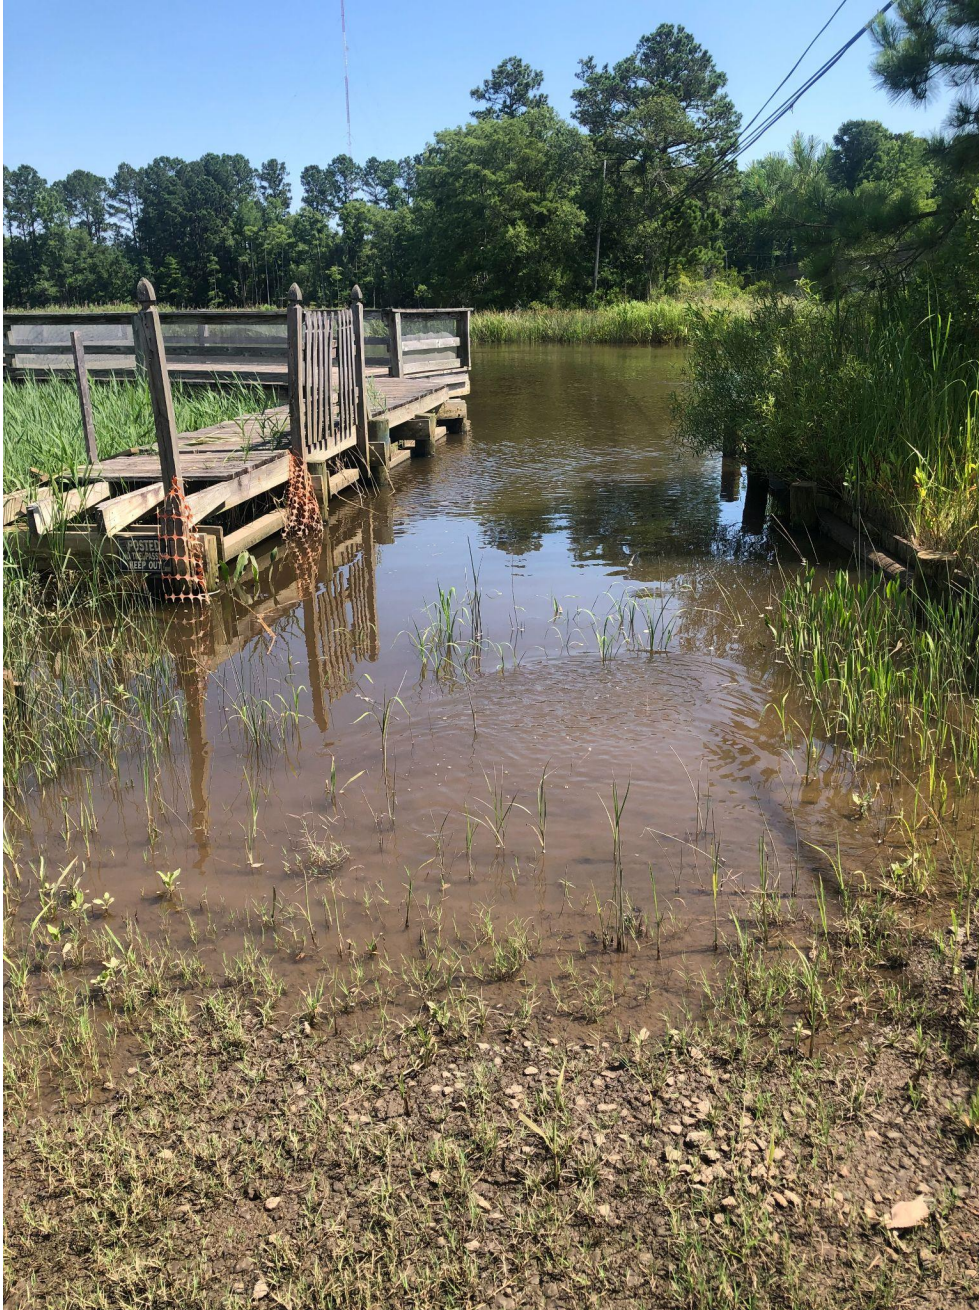
Banks and Tide:

- A. Water: Water surface was a brownish color with high turbidity. High tide. Water was extremely high due to the recent king tide.
- B. Creek Bottom: The creek bottom was not visible due to turbidity.
- C. Vegetation: Spartina grass.
- D. Pipes Present: Pipes present along bridge for drainage.

- A. Creek Bank: Banks are stable with vegetative cover.
- B. Runoff: Runoff from bridge as well as road.
- C. Corridor: Private land surrounding the creek with a public road and bridge crossing over the creek.
- D. Litter: Low amounts of litter. Possibly due to a chain across the access road preventing cars from entering.
